Alpha Home Inspection
201 Faculty Road
Duncannon, Pa. 17020
Office: 717-914-1600
Fax: 570-694-0798
mike@alphainspection.net
www.alphainspection.net

Confidential Inspection Report

02/19/2009.

**123 Heaven Lane
Hometown, PA. 17020.**

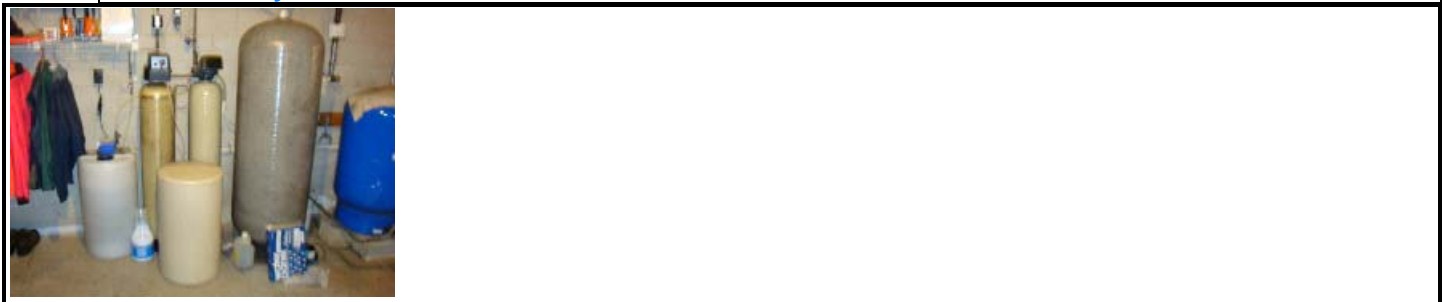
Private
Water treatment system noted. (Not Inspected).Have the seller demonstrate the proper operation of this component. **"Inspectors note" Make inquiry as to the ownership of the water treatment system. In some instances they are leased??**

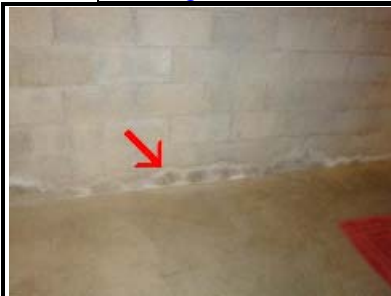
Minor settlement cracks noted, not significant at this time. No need for repairs at this time. [Monitor in the future.](#)
[Staining was observed: Efflorescence seen on walls indicates the presence of periodic moisture.](#)

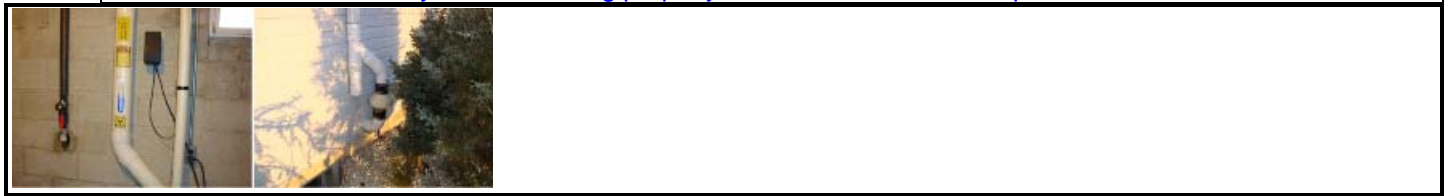
Radon mitigation system noted. "Inspectors tip" Recommend a radon test be performed in the lowest livable part of the home to insure the system is working properly, and the radon level is 4 pCi/L or less.

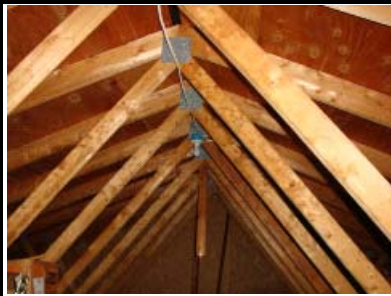
Truss framing, **Viewing was limited**, to observing from hatch areas only. Access is restricted.

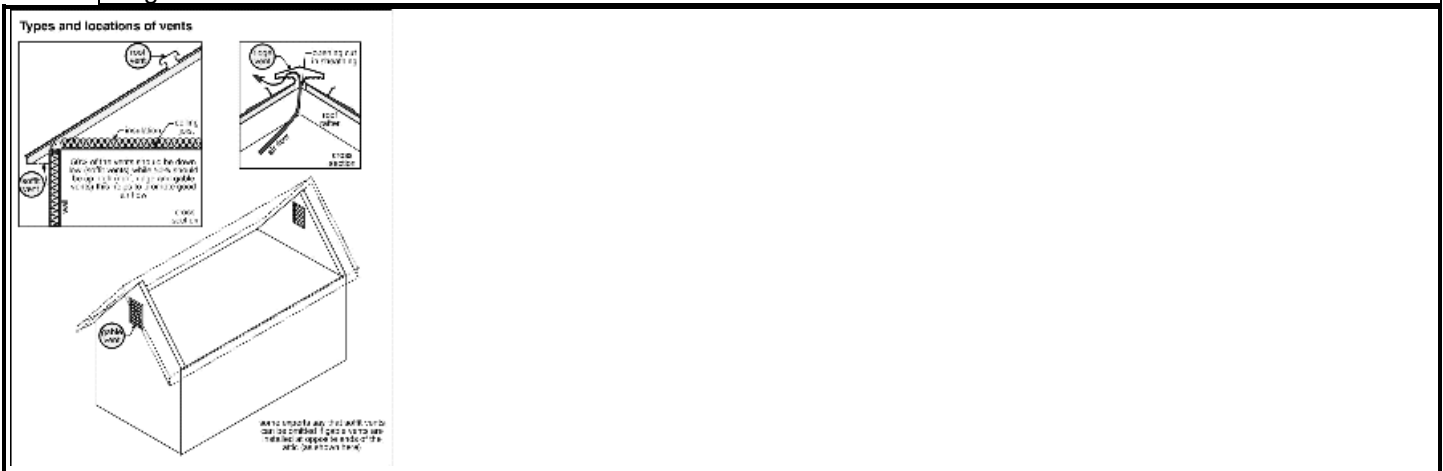
Ridge and soffit vents noted.

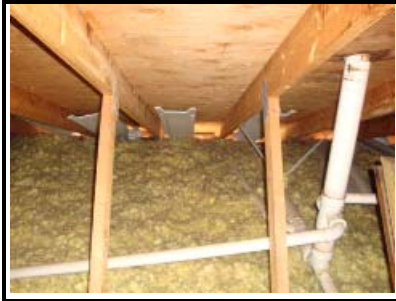
12-14 inches.

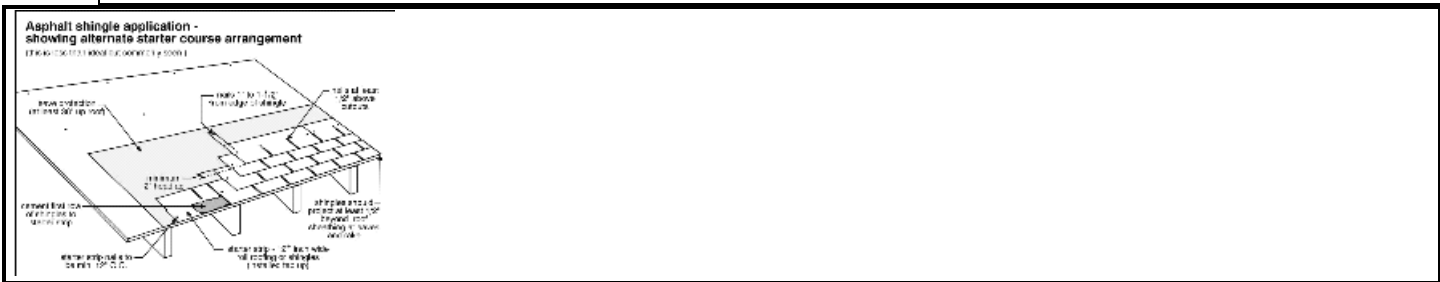
Composition shingles: [Asphalt or fiberglass roofing shingles](#) generally have service lives of 20-25 years for conventional and Architectural style 30-50 years respectively in this area of the country. Early signs of aging include brittleness, minor curling, and loss of mineral granules, while signs of advanced aging are severe curling, broken or split shingles, and exposed felts. The useful life of a roof can be extended by patching and coating eroded or worn areas as they become evident. As a roof approaches the end of its economic life expectancy, patching becomes increasingly necessary, due to an increased likelihood of leakage in the last few years of roof life.

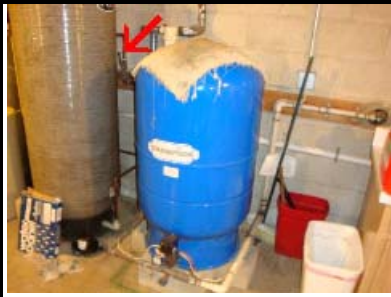
Water tank and main shut off valve is located in the basement. (Valve NOT Tested)

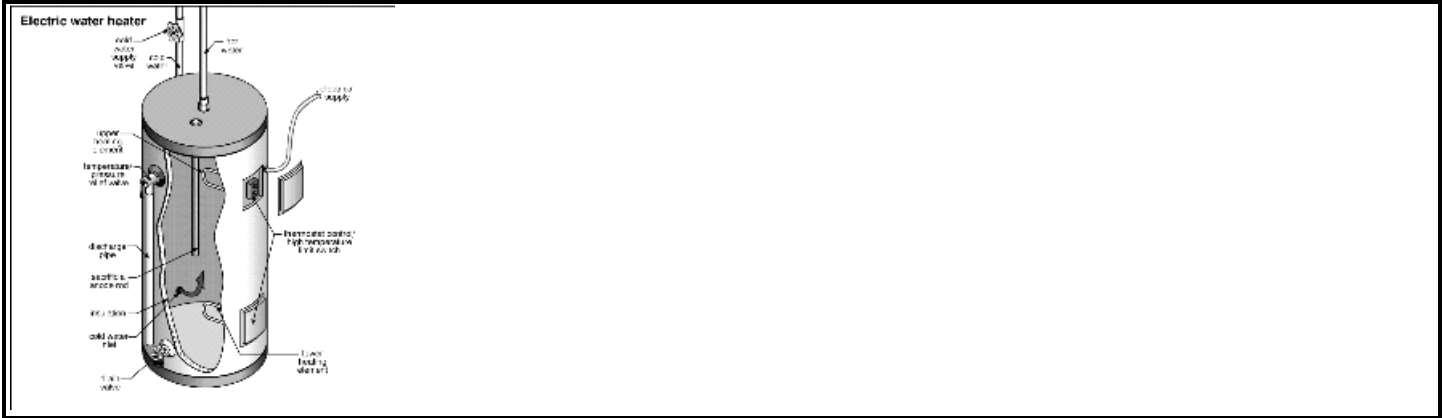
WATER HEATER #1:

Electric.

Appears to be original when home was constructed. Water heater is old and life expectancy is difficult to predict. The [estimated](#) service life of an electric water heater is 20 years.

A water shutoff valve is installed, not tested.
Pressure relief valve noted, not tested.

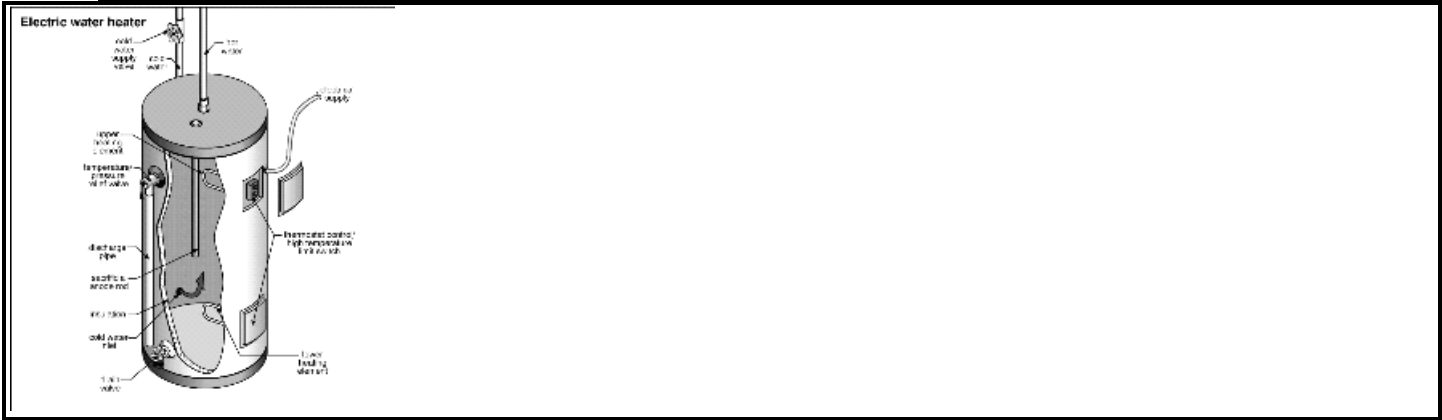
WATER HEATER #2:

Electric.

Appears to be original when home was constructed. Water heater is old and life expectancy is difficult to predict.

A water shutoff valve is installed, not tested.
Pressure relief valve noted, not tested.

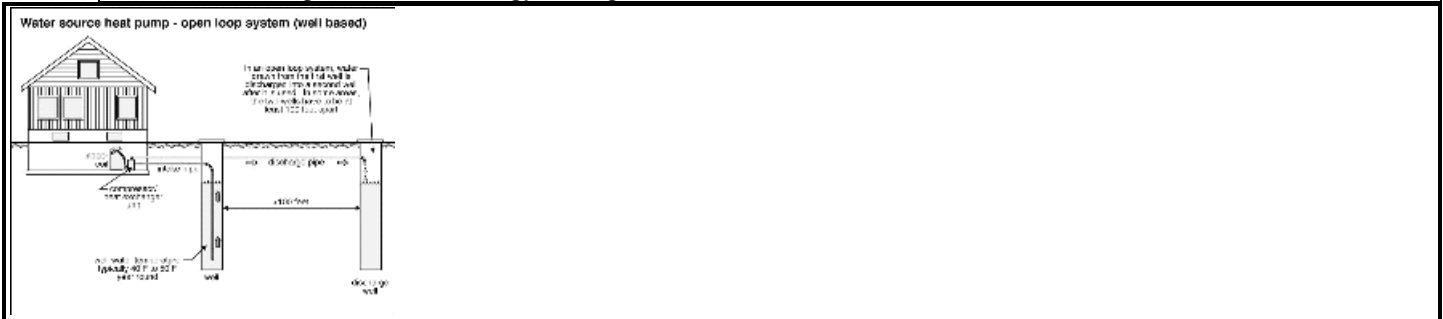
Water source Heat Pump. A Geothermal heat pump works on the principal that water (Average is 52 degrees in Pennsylvania), has some heat in it which can be extracted and used within the house. The benefit of the ground water system is that unlike an air to air heat pump which has to operate at fluctuating and often extreme exterior temperatures the ground water is a constant temperature. This allows the system not to work as hard to produce heat thus allowing substantial energy savings.

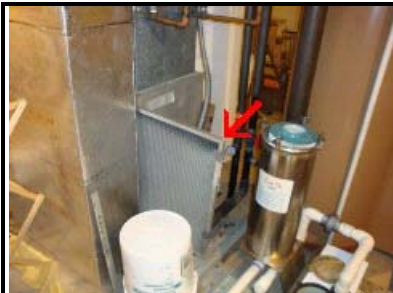
Filter Size is 25x25x1. Filter is dirty, replacement/cleaning required.

- A. Replace/clean filter monthly or more often if it becomes dirty
- B. Recommend the system be serviced routinely by a licensed Heat Pump Contractor.
- C. Heating system should be placed under a maintenance contract.
- D. Consult with a licensed heating contractor for proper summer and winter settings.
Proper seasonal settings will conserve energy.

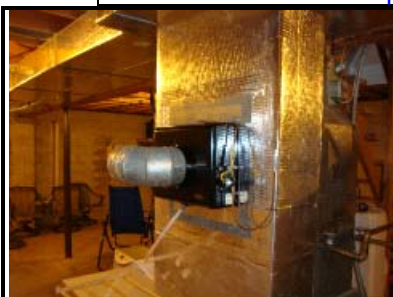
The heating system is equipped with humidifier. Humidifiers are beyond the scope of this inspection. Have the sellers demonstrate the proper operation of this component prior to taking possession of the property.

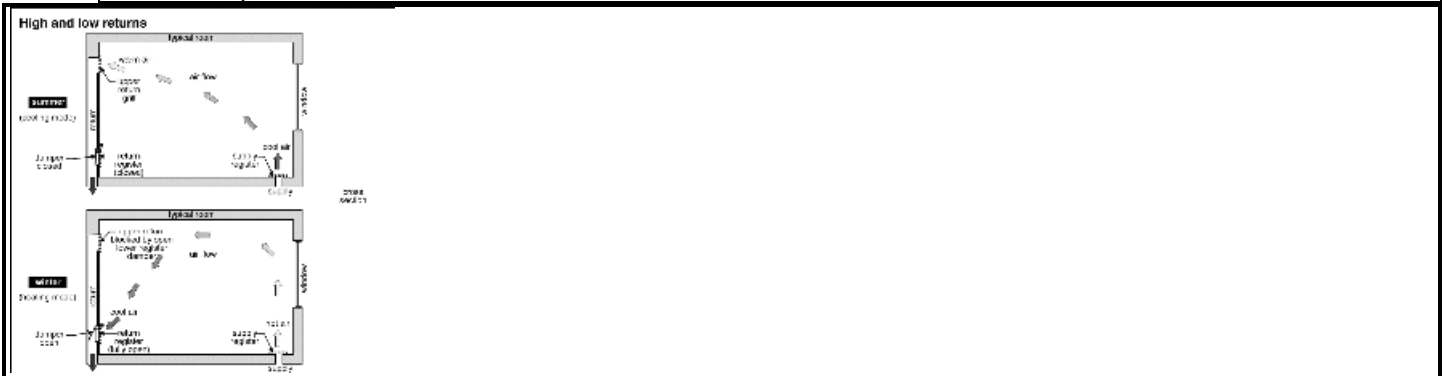
Both upper and lower return vent system noted. Upper vents should be open in the summer and lower vents should be open in the winter. "SEE ILLUSTRATION"

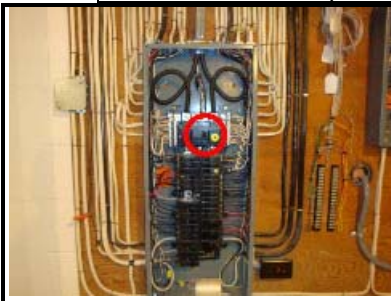
Basement, 200 Amp. Main breaker noted NOT tested. Appears serviceable.

Circuit and wire sizing correct so far as visible.
Grounding system is present.

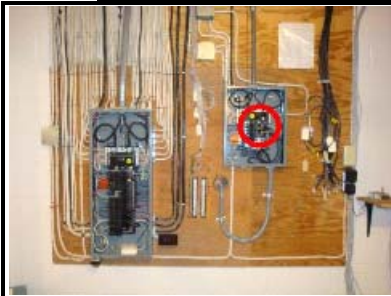
Basement, 100 Amp. Main breaker noted NOT tested. Appears serviceable.

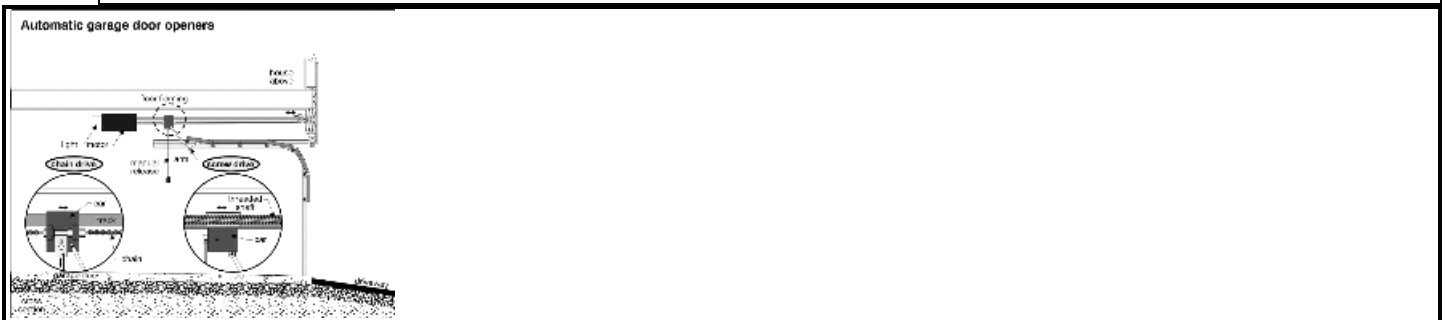
Automatic door opener(s)- operational, Automatic reverse feature is, operational. *"Inspectors safety tip"* All overhead doors should have fully operational auto-reverse function to insure safe conditions. Electric garage door openers produced after 2001 have sensor eyes and an auto-reverse feature which acts to stop and reverse the door should some object (a child) be encountered while the door is closing. It is a safety protection device and its proper adjustment should not be neglected. Adjustment screws are generally labeled and within easy reach with a screwdriver. These mechanisms should be adjusted so they will reverse upon contacting something soft, such as a child or family pet. Use a basketball, placed in the path of the closing door to test this function and adjust as needed.
